Bushland Management Strategy

Vineyard Creek, Western Sydney University Parramatta
Campus

Report prepared by Narla Environmental Pty Ltd

April 2018

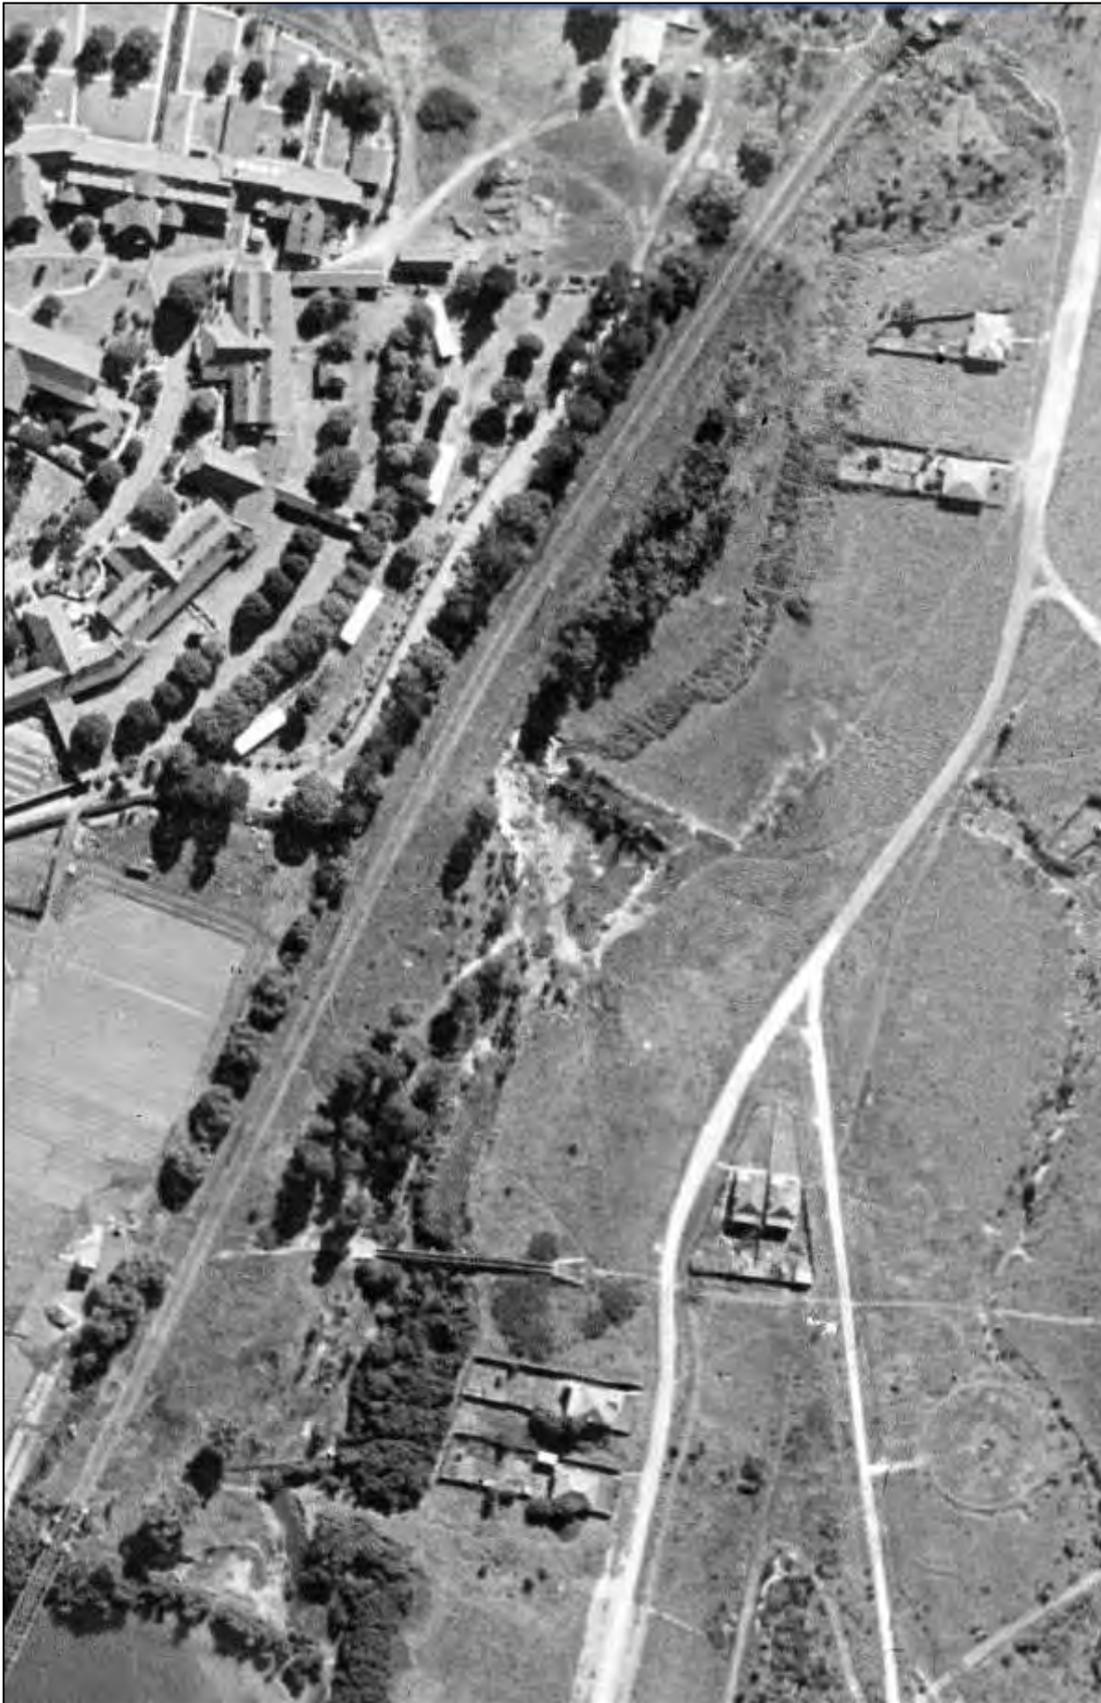
Figure 2. Historical aerial imagery (C.1943) displaying the partially cleared subject site

The subject site comprises the easternmost extent of the Western Sydney University's Parramatta Campus. Historically, the area had been partially cleared, leaving only two small areas of remnant vegetation assumed to still be standing within the subject site as was the case in 1943 (**Figure 2**).

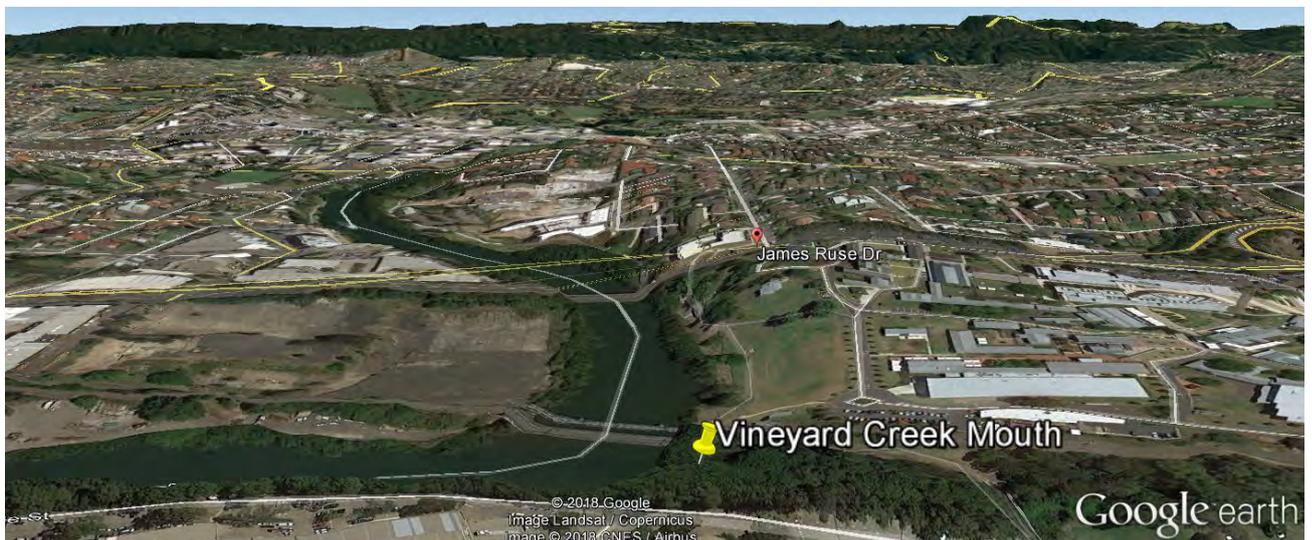
Figure 4. A Google Earth terrain view image showing a view from the mouth of Vineyard Creek (the subject site) looking up the Parramatta River toward Parramatta. Note the dense vegetation (mangrove) fringe in either side of the river, along with the notable increased hard surfaces and industry.

A comparison of the landscape along Parramatta River and the mouth of Vineyard Creek is presented c. 1837 (**Figure 3**) the present day (**Figure 4**).

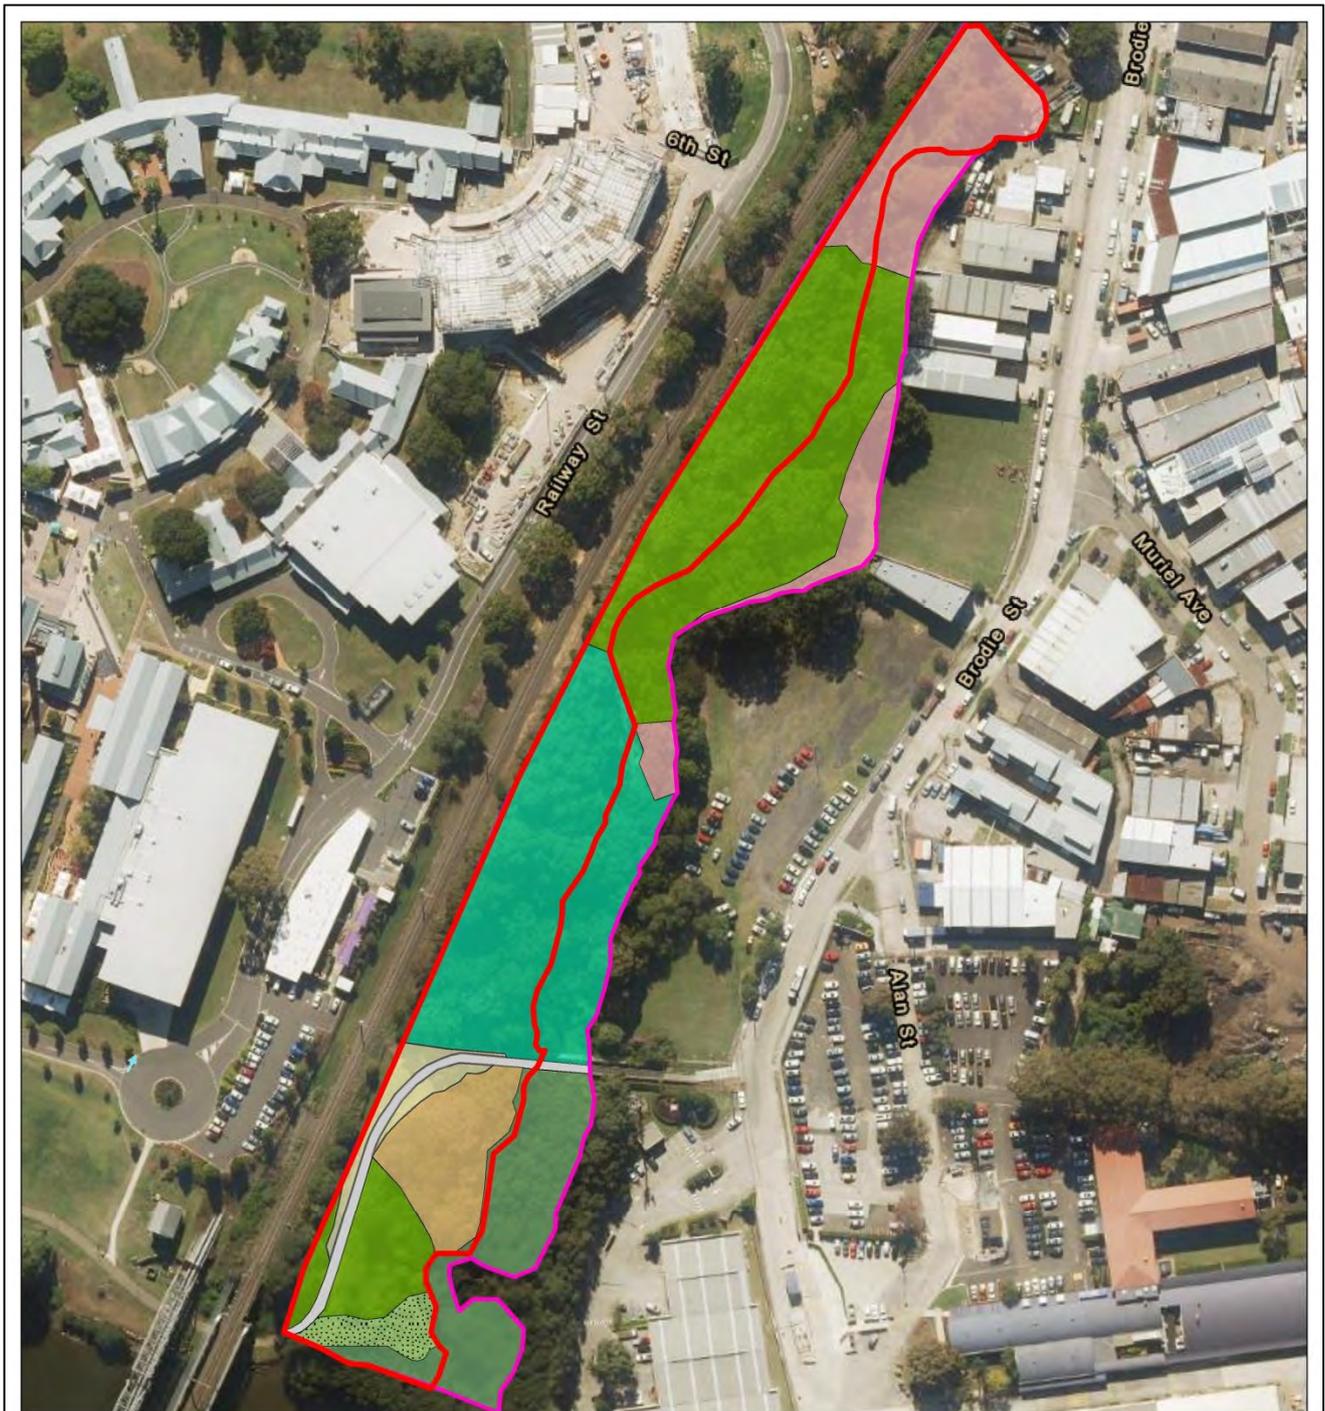
Figure 6. Confirmed vegetation communities observed within the subject site

Narla Environmental identified a diverse suite of vegetation communities across the subject site. This included four EEC. Vegetation Communities identified within the subject site are detailed in **Table 1** and **Figure 6**.

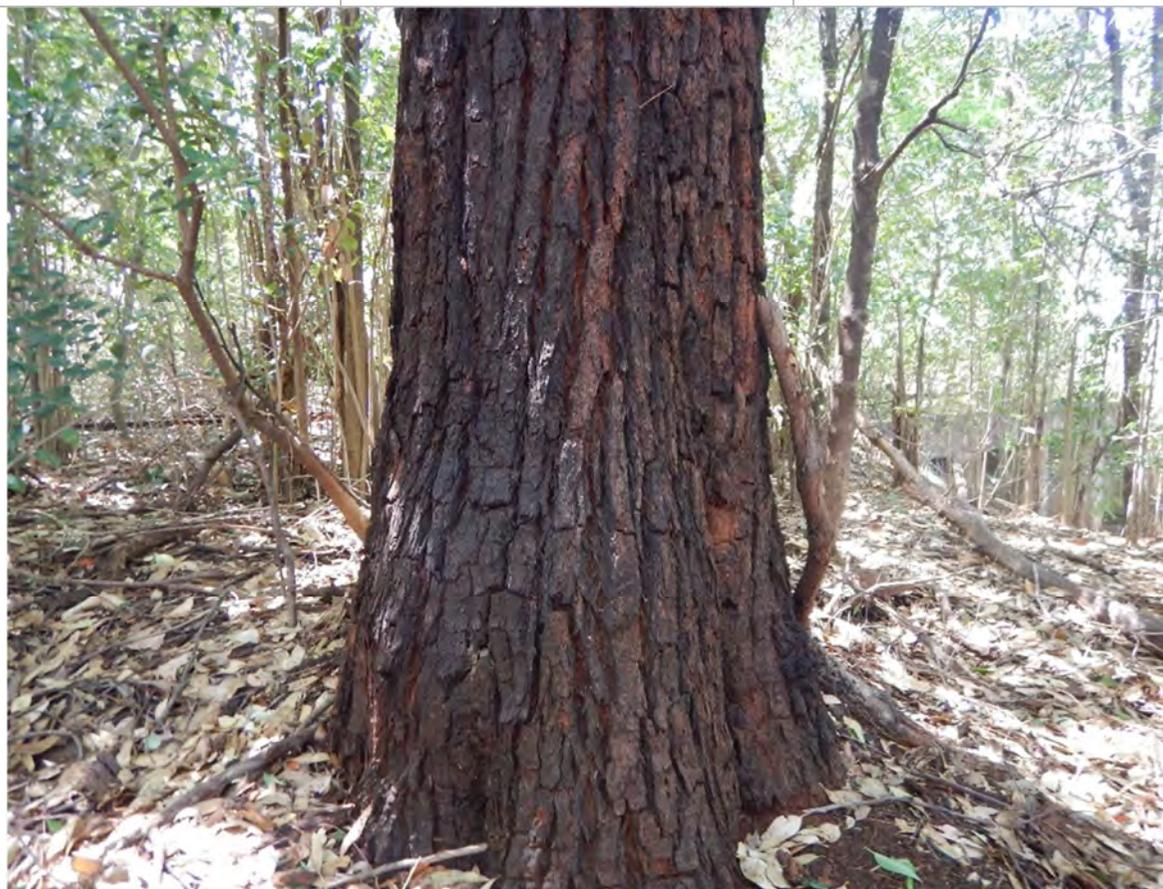
Narla Unit	Map	Photo	Sydney Metropolitan Vegetation Mapping (OEH 2013)	Plant Community Type (PCT)	Biodiversity Conservation Act 2016 Status	Environment Protection and Biodiversity Conservation Act 1999 Status
Swamp Sclerophyll Forest			Coastal Flats Swamp Mahogany forest (S_FoW02)	1795: Coastal Flats Swamp Mahogany Forest	Swamp sclerophyll forest on coastal floodplains of the NSW North Coast, Sydney Basin and South East Corner bioregions – Endangered Ecological Community	Not Listed

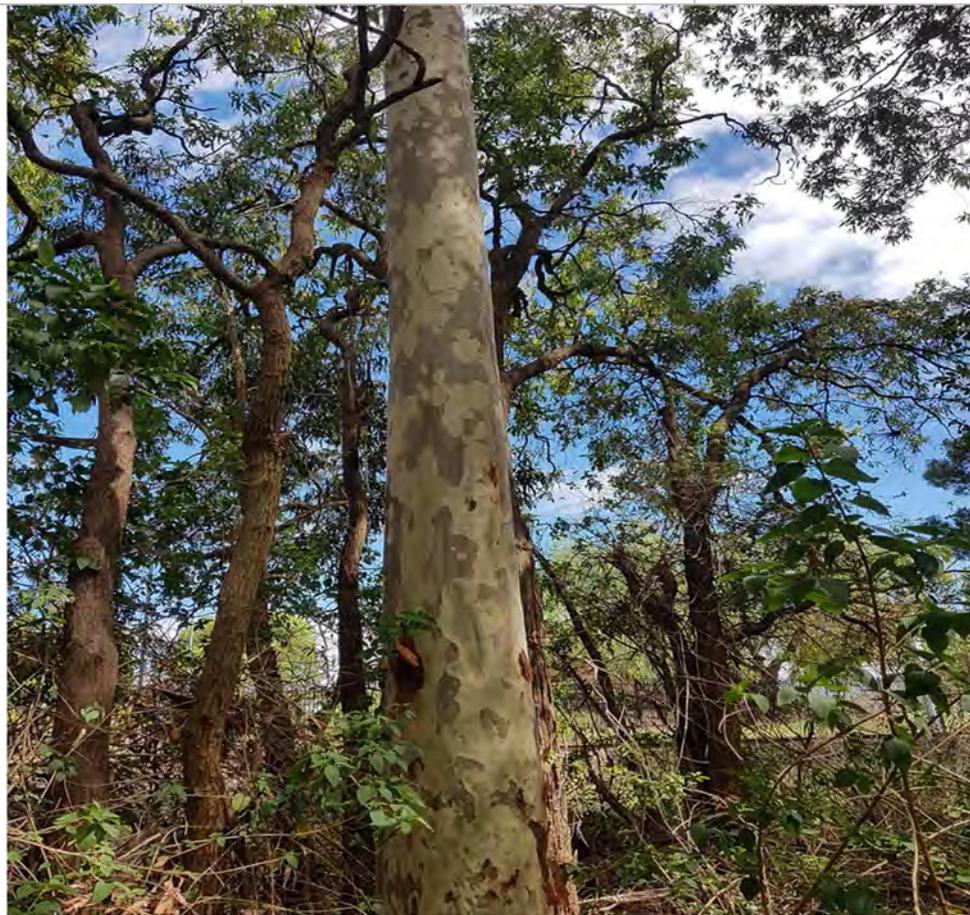
Narla Map Unit	Map	Photo	Sydney Metropolitan Vegetation Mapping (OEH 2013)	Plant Community Type (PCT)	Biodiversity Conservation Act 2016 Status	Environment Protection and Biodiversity Conservation Act 1999 Status
River-flat Eucalyptus Forest			Cumberland Riverflat Forest (S_F0W06)	835: Forest Red Gum-Rough-barked Apple Grassy Woodland on Alluvial Flats of the Cumberland Plain, Sydney Basin	River-flat eucalypt forest on coastal floodplains of the NSW North Coast, Sydney Basin and South East Corner bioregions - Endangered Ecological Community	Not Listed

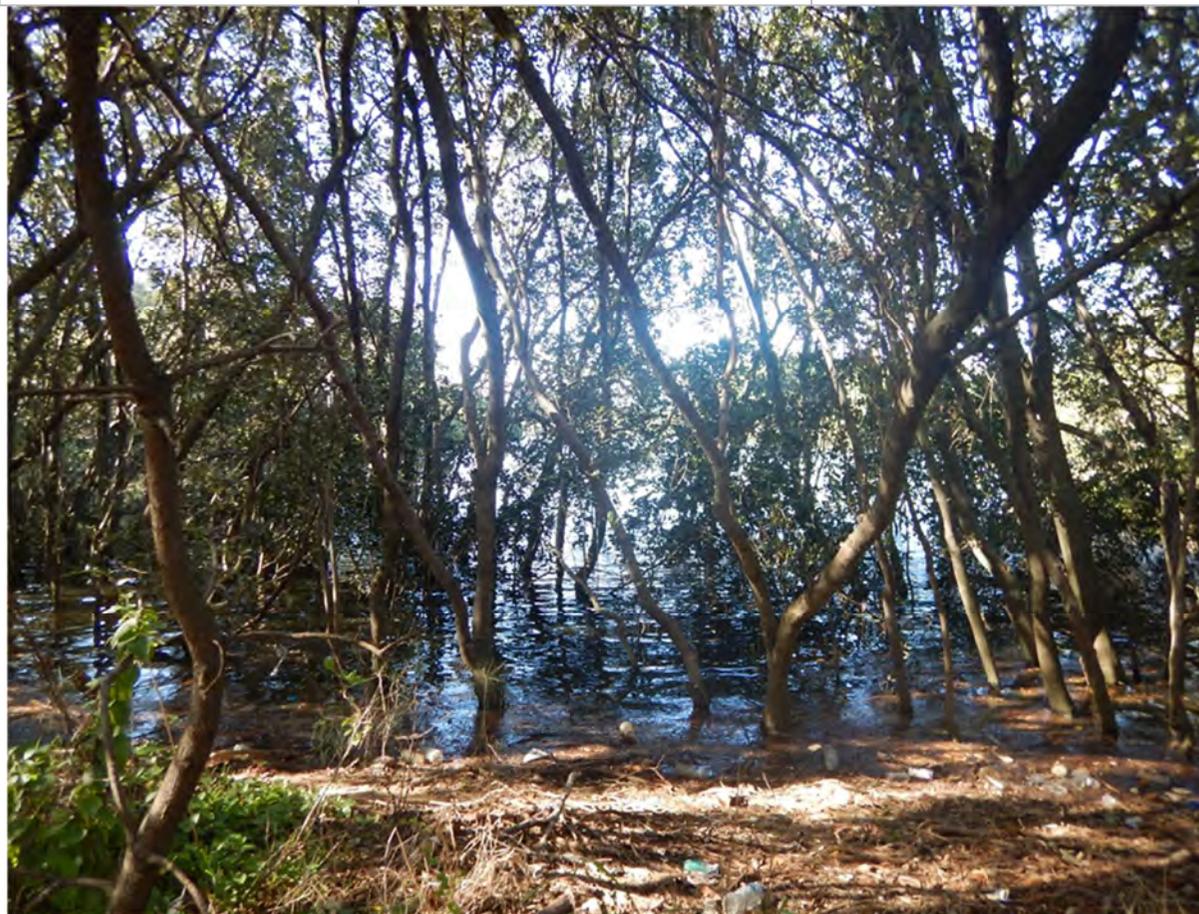
Narla Map Unit	Map	Photo	Sydney Metropolitan Vegetation Mapping (OEH 2013)	Plant Community Type (PCT)	Biodiversity Conservation Act 2016 Status	Environment Protection and Biodiversity Conservation Act 1999 Status
Estuarine Mangrove Forest			Estuarine Mangrove Forest (S_SW01)	920: Mangrove Forest in Estuaries of the Sydney Basin and South East Corner	Not Listed	Not Listed

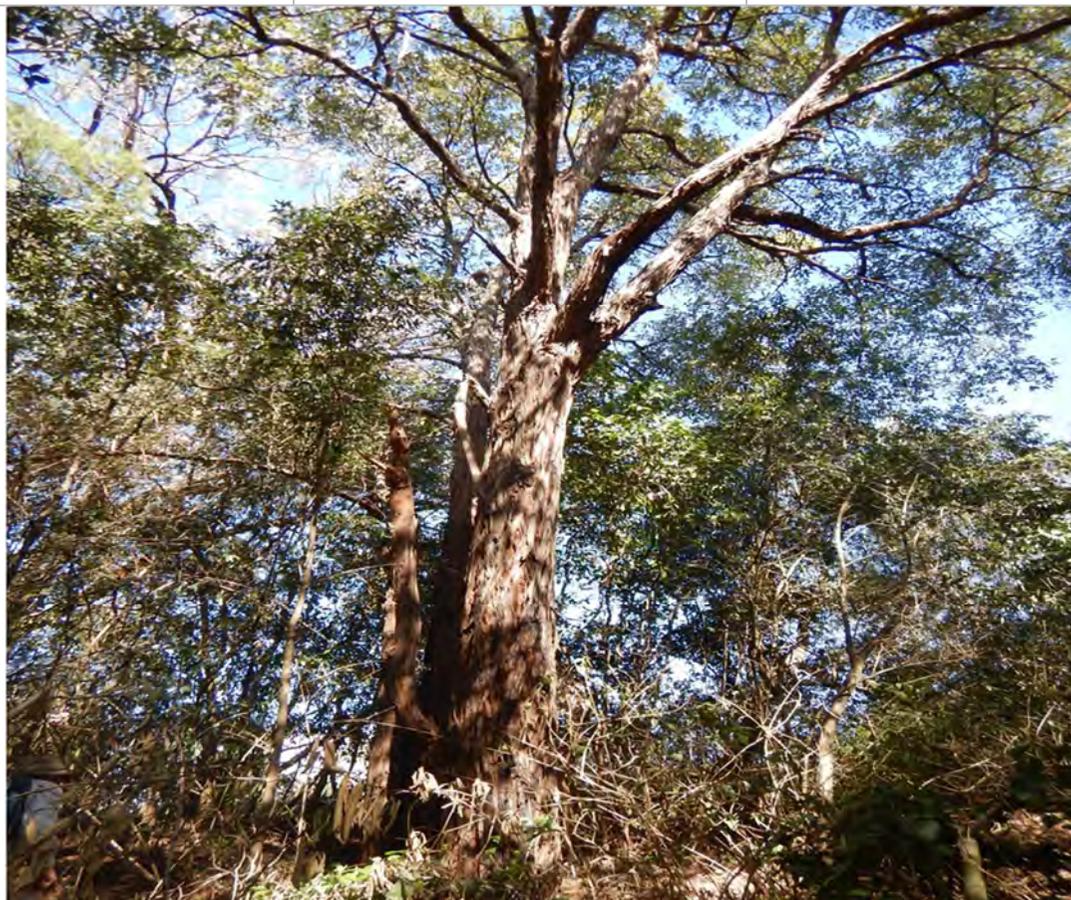
Nara Map Unit	Photo	Sydney Metropolitan Vegetation Mapping (OEH 2013)	Plant Community Type (PCT)	Biodiversity Conservation Act 2016 Status	Environment Protection and Biodiversity Conservation Act 1999 Status
Shale Gravel Transition Forest		Castlereagh Shale-Gravel Transition forest (S_DSFO2)	724: Broad-leaved Ironbark-Grey Box-Melaleuca decora Grassy Open Forest on Clay/Gravel Soils of the Cumberland Plain, Sydney Basin	Shale Gravel Transition Forest in the Sydney Basin Bioregion – Endangered Ecological Community	Cumberland Plain Woodlands and Shale-Gravel Transition Forest – Critically Endangered Ecological Community

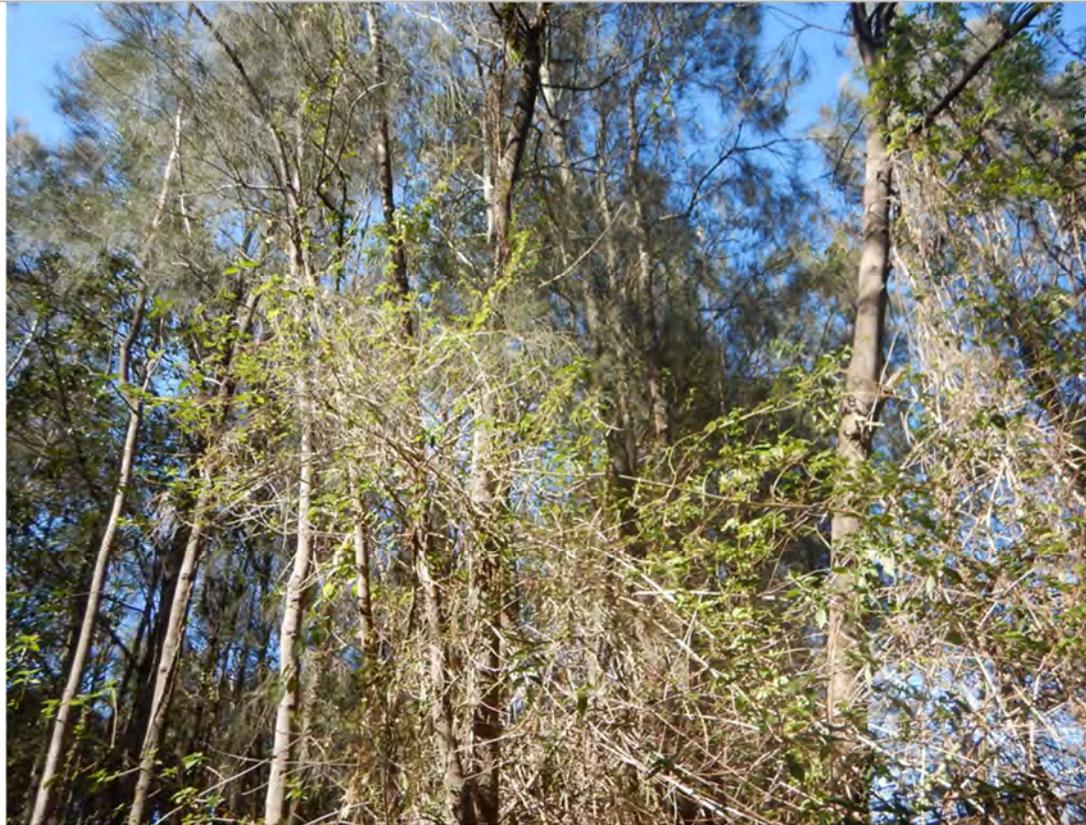
Narla Map Unit	Photo	Sydney Metropolitan Vegetation Mapping (OEH 2013)	Plant Community Type (PCT)	Biodiversity Conservation Act 2016 Status	Environment Protection and Biodiversity Conservation Act 1999 Status
Swamp Oak Floodplain Forest		Estuarine Swamp Oak Forest (S_FoW08)	1234: Swamp Oak Swamp Forest Fringing Estuaries, Sydney Basin and South East Corner	Swamp Oak Floodplain Forest of the New South Wales North Coast, Sydney Basin and South East Corner Bioregions – Endangered Ecological Community	Not Listed

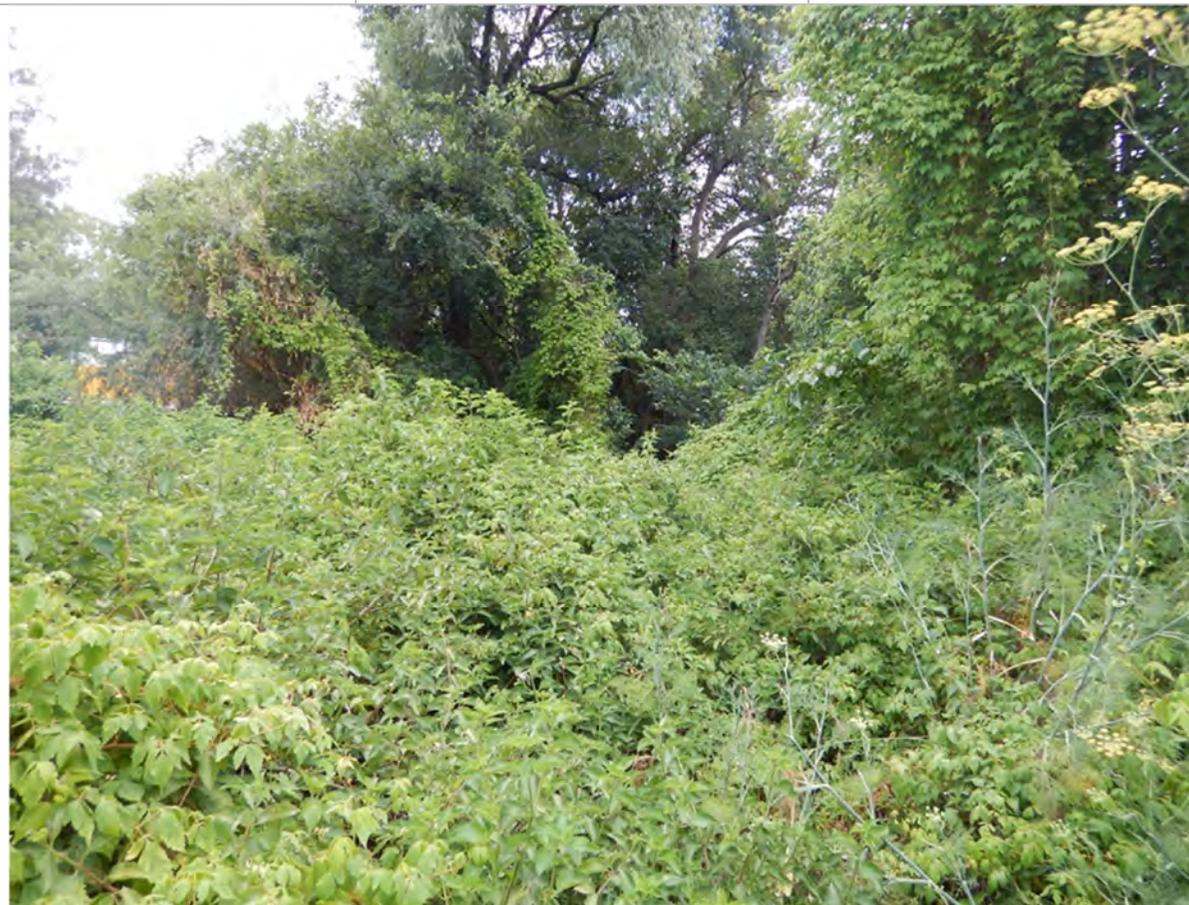
Narla Map Unit	Photo	Sydney Metropolitan Vegetation Mapping (OEH 2013)	Plant Community Type (PCT)	Biodiversity Conservation Act 2016 Status	Environment Protection and Biodiversity Conservation Act 1999 Status
Noxious and Invasive Weeds		Noxious and Invasive Weeds	N/A	N/A	N/A

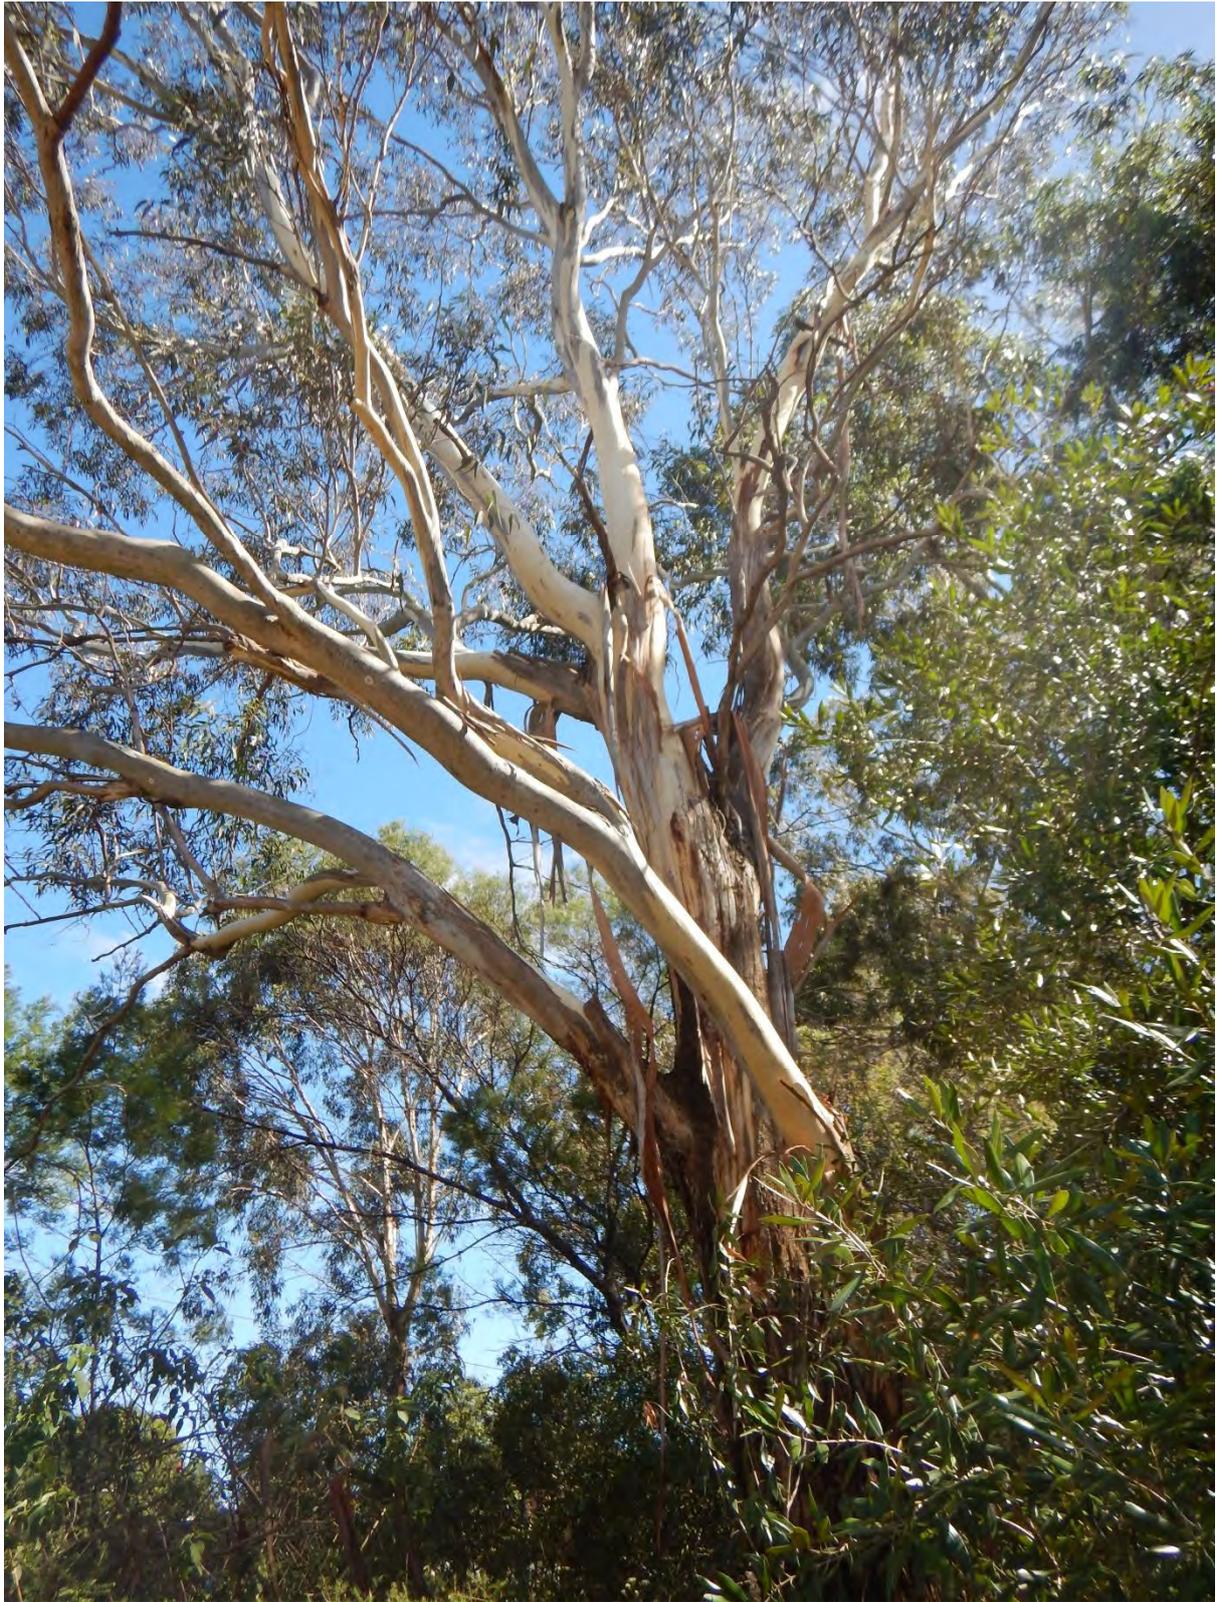
While it is not a threatened species, a stand of the tall, native tree, the River Peppermint (*Eucalyptus elata*) was recorded in the subject site (**Plate 1**) within the area mapped by Narla as 'Riverflat Forest' (**Figure 6**). This attractive, tall tree species is indigenous to the Parramatta River area as evident from historical paintings of mature individuals growing along the banks of the Parramatta River near the subject site (**Figure 3**). This tree is not known to currently occur within the Sydney Metropolitan Area (OEH 2016). The small population on the subject site may be the only natural population in metropolitan Sydney and therefore should be considered regionally significant.

Plate 1. A River Peppermint (*Eucalyptus elata*) that forms part of a stand present in the Subject Site. This species is indigenous to the area and may form part of a significant local population.

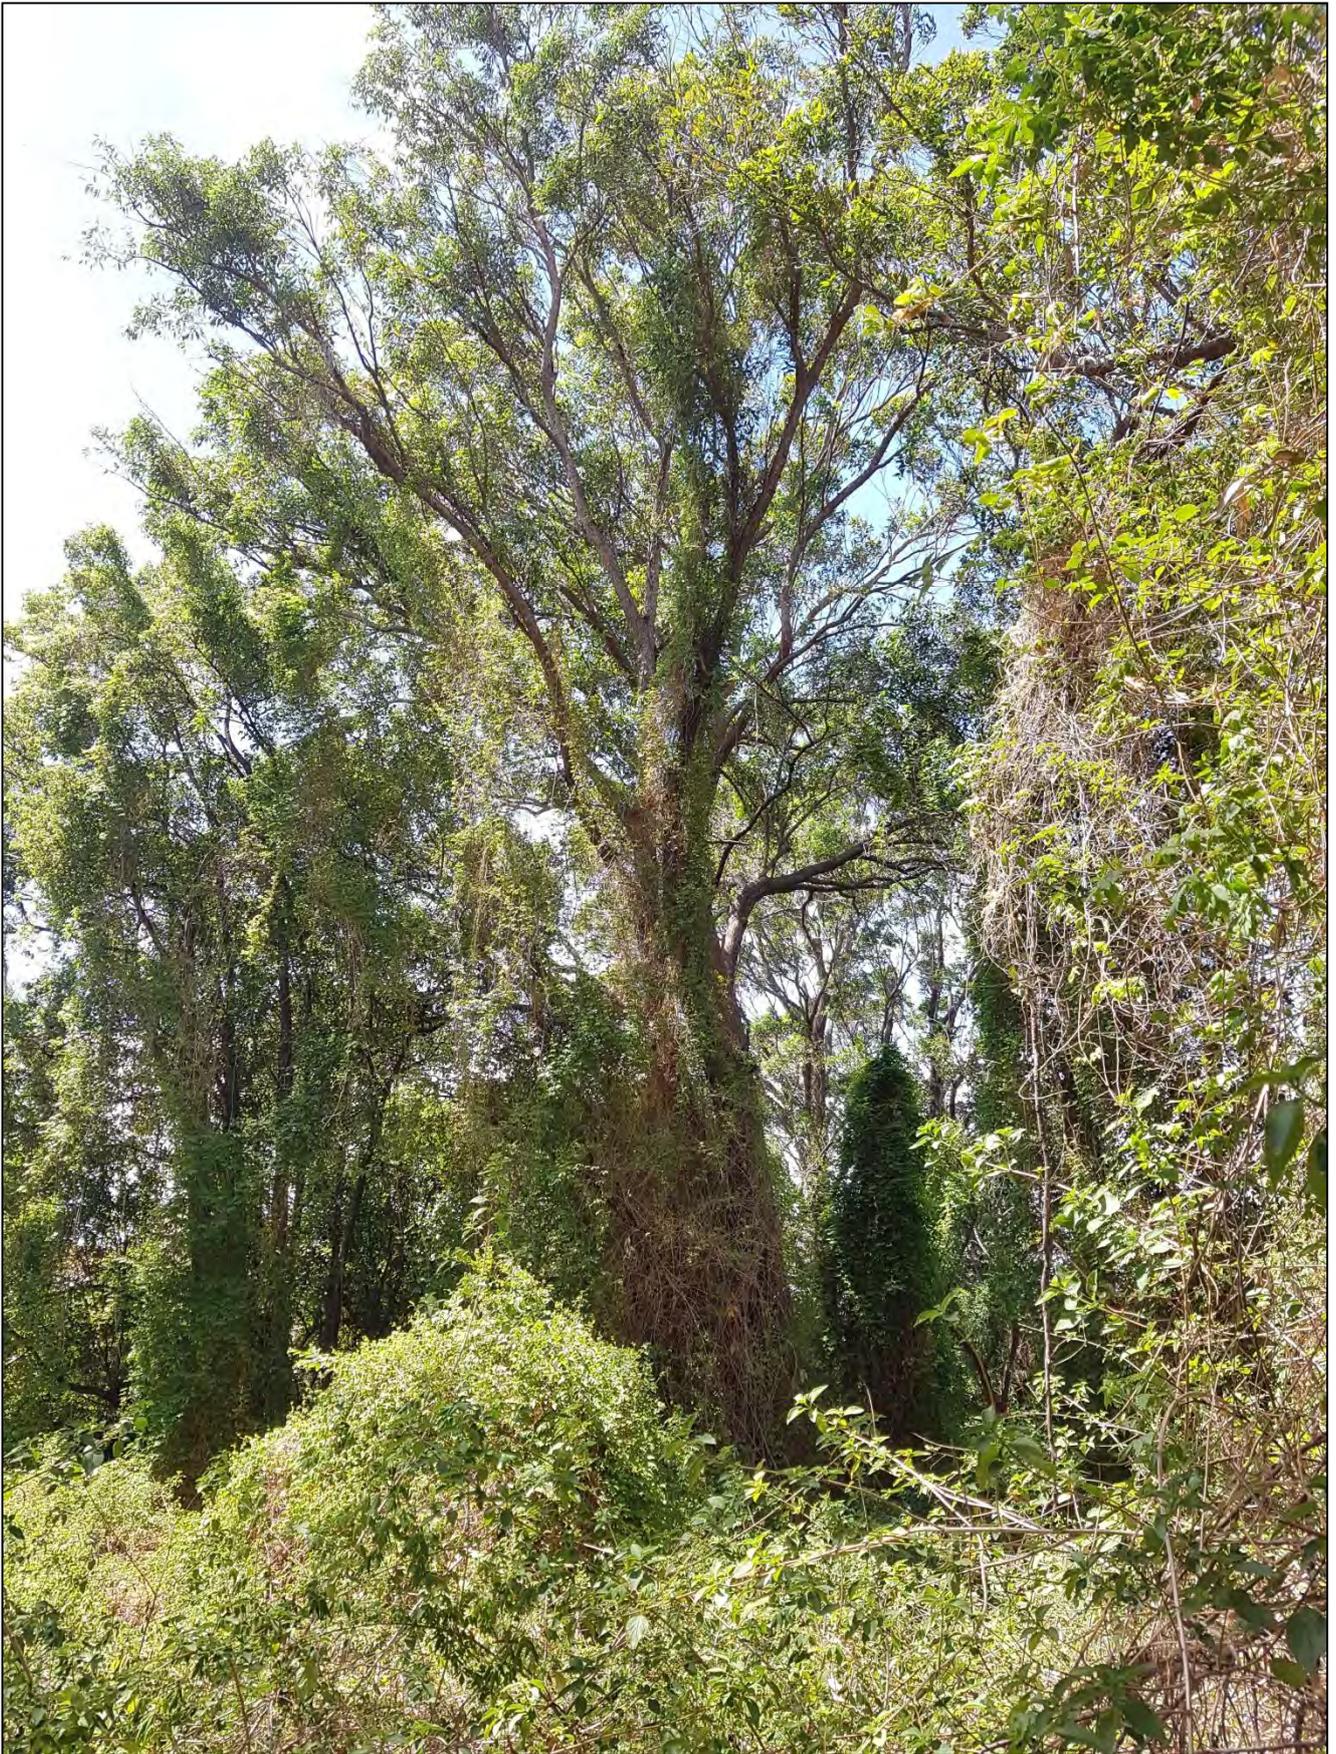
Plate 2. Invasive vines and climbers threatening the viability of the native canopy in the subject site

Weed infestation is considered to be the most significant management issue affecting the subject site. Narla recommend that the professional management of weeds is implemented as soon as is practicable and that priority be given to remove and control WoNS and weed species listed as 'priority' within the Greater Sydney area. Effort should be made to progressively expand the quality of native vegetation communities through the gradual replacement of weeds with ecologically-equivalent native plants. This can be achieved through the action of professional Bushland Restoration professionals with the aid of on-going efforts driven by volunteers (e.g. local environment groups, university bushland / environmental clubs or BushCare Groups).

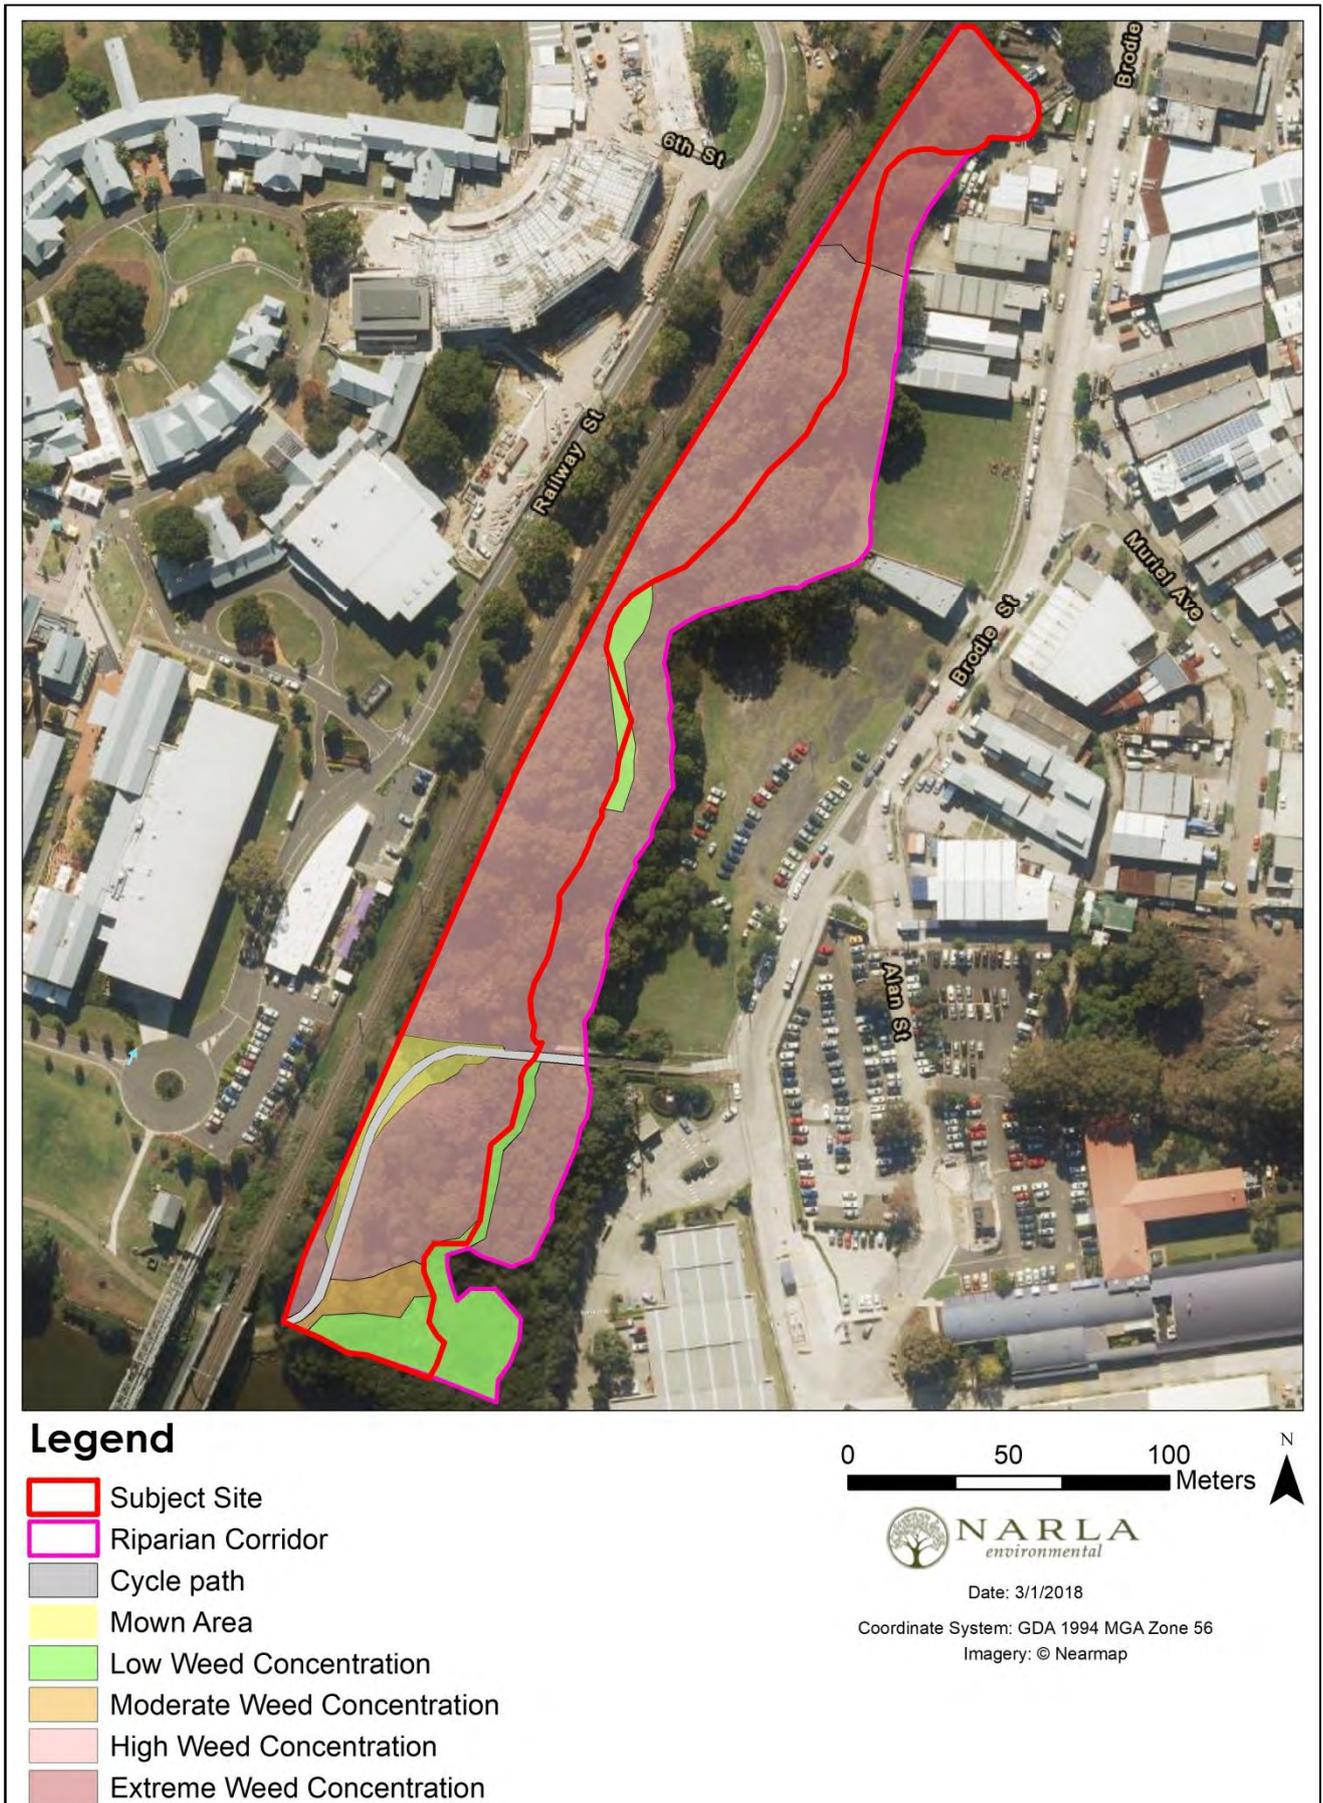
Figure 7. Weed concentrations across the subject site

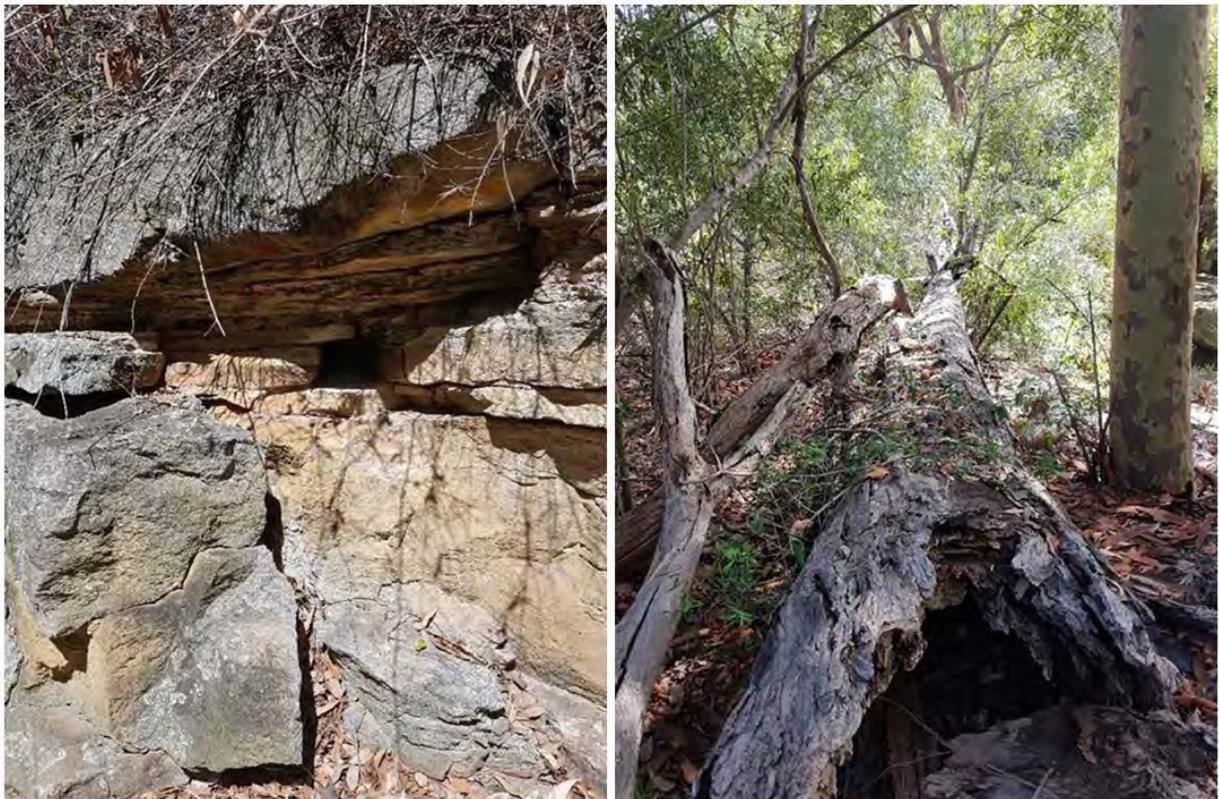
Plate 3. Important fauna habitat features on the subject site (sandstone crevices left) and coarse woody debris (right)

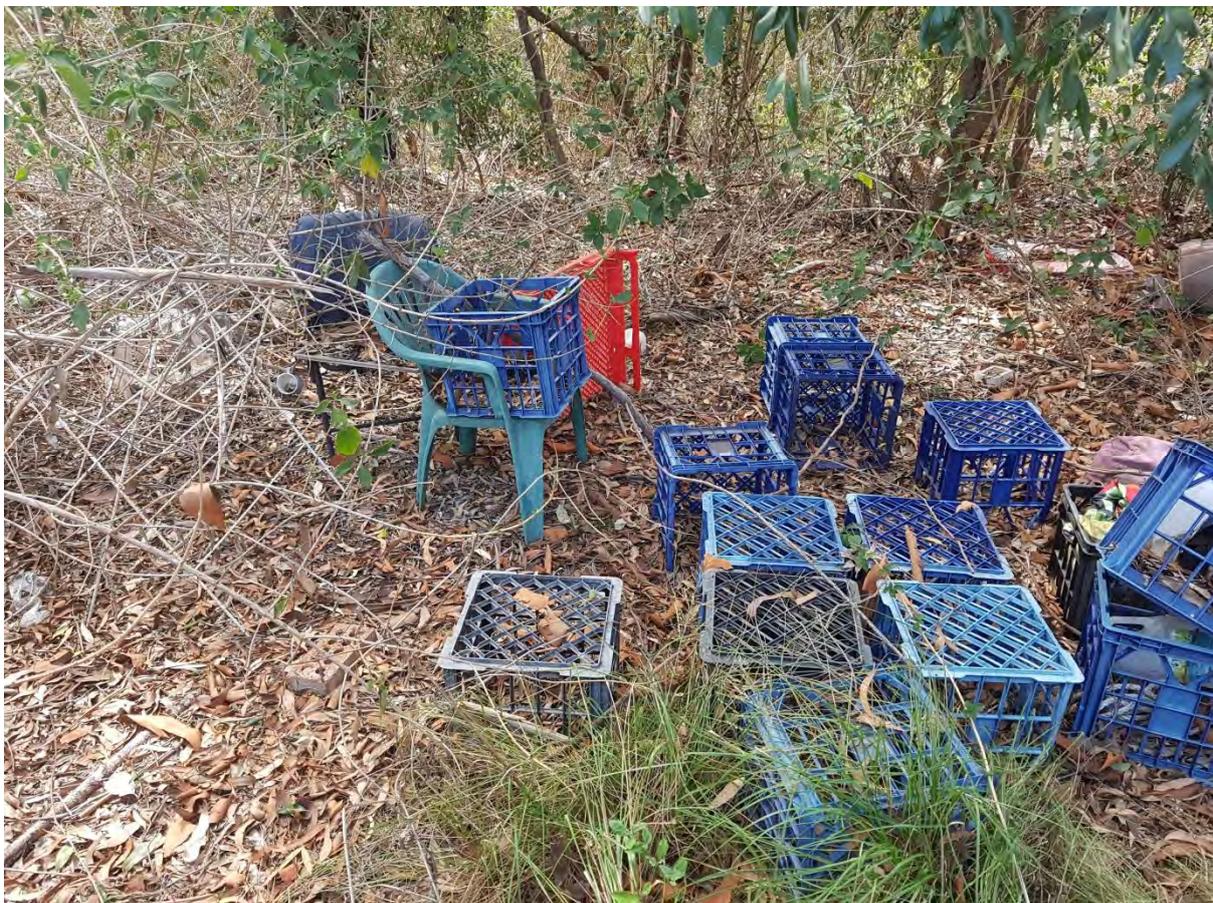
The illegal dumping of waste material and illegitimate occupancy of the site was identified as a management issue. A dumped car engine block as well as an abandoned camp (**Plate 4**) were identified within the subject site. Disturbed areas where dumping occurs are likely to support weed plumes and infestations. Such areas may also be susceptible to increased risk of fire or erosion. Waste products could enter the riparian environment and cause environmental degradation.

Plate 4. Evidence of illegal camp within the subject site.

Illegal dumping can impede bushland management actions as it may act as a continual source of weed propagules and has the ability to crush native regeneration and introduce contaminants which put the environment and public at risk. While large pieces of anthropogenic waste such as old tyres or sheet metal may provide some shelter habitat for native fauna, such as reptiles, amphibians and invertebrates, natural coarse woody debris provides superior habitat values and is recommended to replace removed waste.

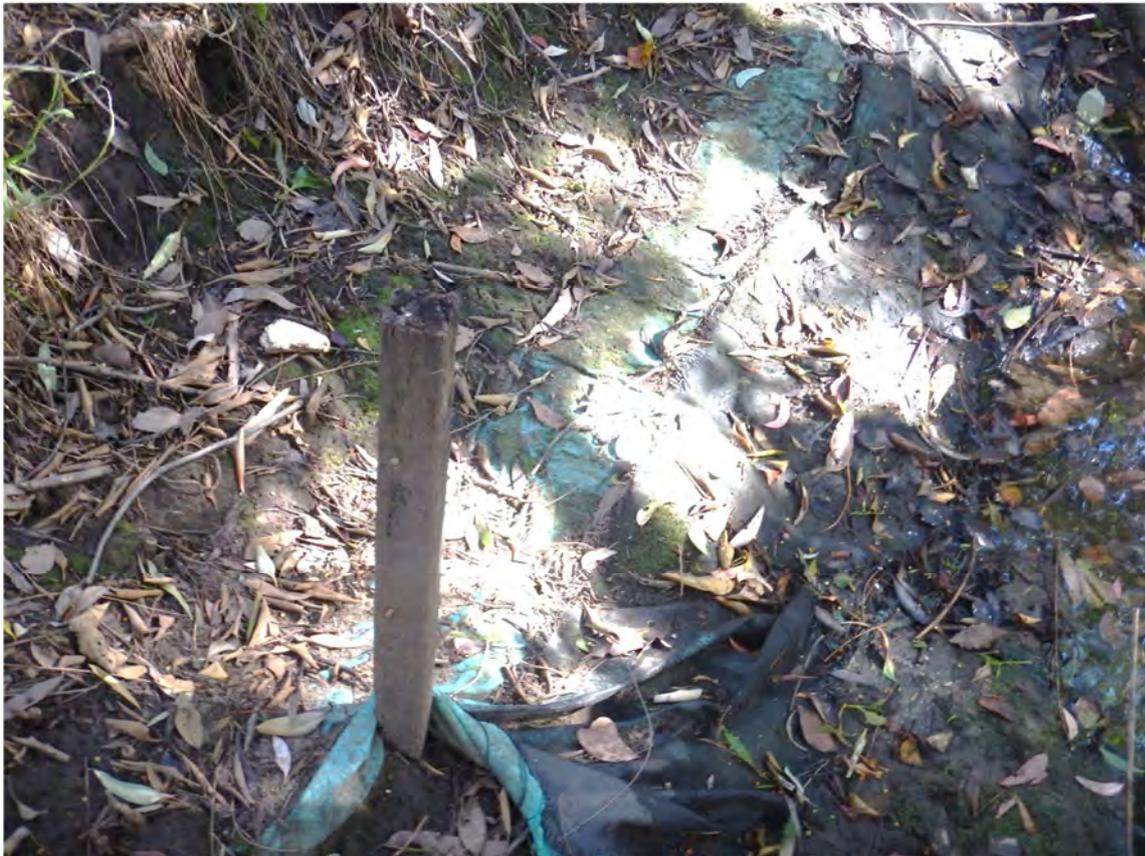
Small areas of localised erosion were evident within the subject site. Past erosion control measures were evident along areas within the southern extent of Vineyard Creek in the form of erosion fencing. This fencing was intact in areas and had been compromised in other areas (**Plate 5**). Increased sedimentation of vineyard Creek is likely to reduce the habitability of the watercourse for native aquatic and semi-aquatic fauna.

Plate 5. Compromised sediment retention fencing along Vineyard Creek

It is recommended that the damaged sediment fencing along the western bank of Vineyard Creek, in the southern extent of the subject site be at least removed and ideally, replaced. As the damaged fencing material continues to deteriorate, it poses a risk to the health of the native fauna within the creek as well as not preventing the mobilisation of sediments and other material into the water course as it is intended to do.
