Bushland Management Strategy

Vineyard Creek, Western Sydney University Parramatta
Campus

Report prepared by Narla Environmental Pty Ltd

April 2018

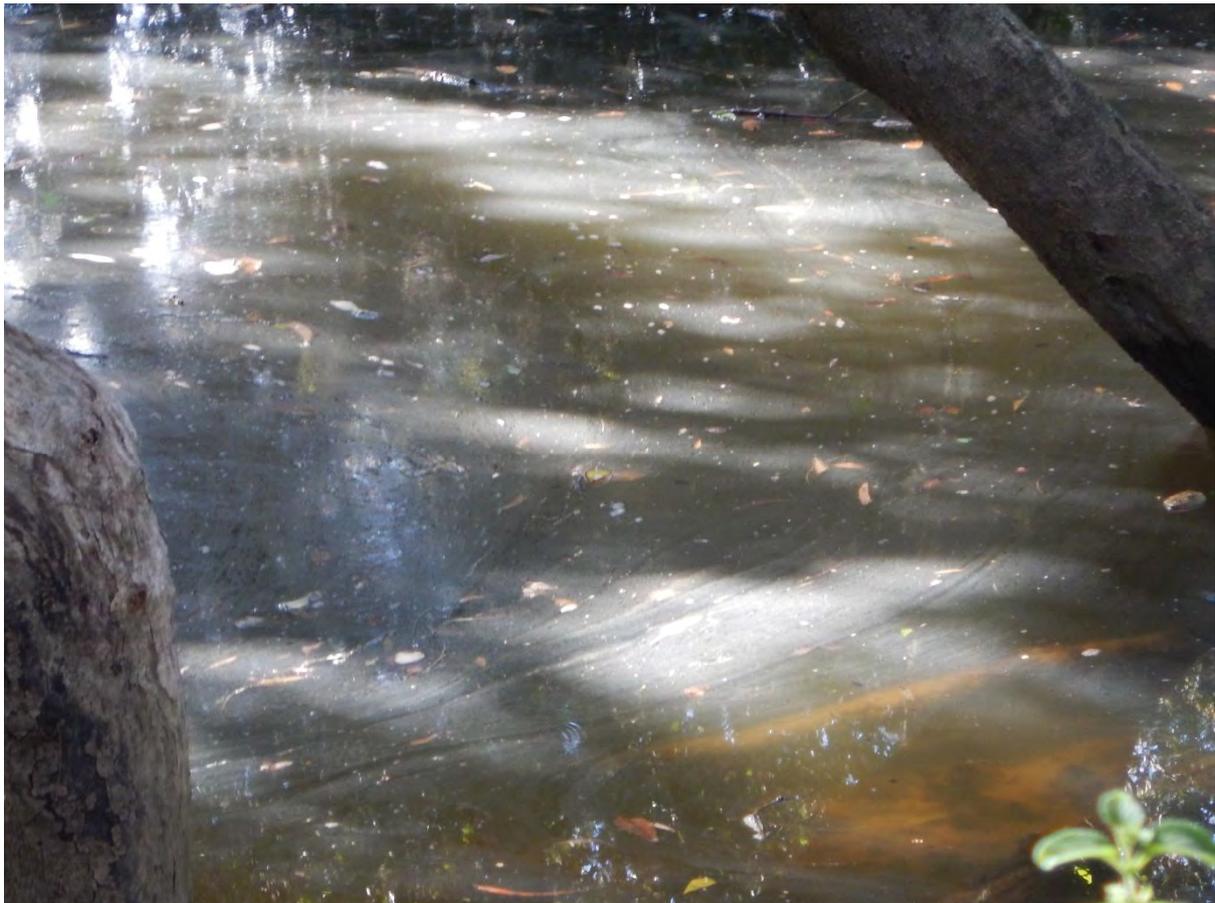
The water within Vineyard Creek was observed to contain both micro and macro pollutants, including a dense surface slick (**Plate 6**). A considerable amount of plastic waste had entered the subject site, presumably via the northern extent of vineyard creek.

Although comprehensive water and sediment tests were not undertaken as part of this assessment, it is possible that the level of pollution evident within and surrounding the watercourse is a contributing factor to the lack of sensitive bio-indicators such as native frog species or a diverse aquatic macroinvertebrate assemblage.

Plate 6. Pollution within Vineyard Creek

As a result of the visible macro and micro pollution observed within Vineyard Creek, Narla Environmental recommends the implementation of a floating pollution collection/ exclusion boom to reduce the impact of water borne pollution within the subject site. Such a device should be implemented at the northern extent of the subject site where it could prevent the mobilisation of macro-pollutants throughout the subject site and would not inhibit the dispersal of mangrove propagules within the brackish, southern extent of the subject site.

It is recommended that regular water quality monitoring is undertaken within Vineyard Creek. This could be undertaken monthly or biannually, and focus on assessing nutrient levels, pollutants (e.g. hydrocarbons, pesticides and heavy metals), algal blooms and biodiversity indicators (e.g. macroinvertebrate assemblages).

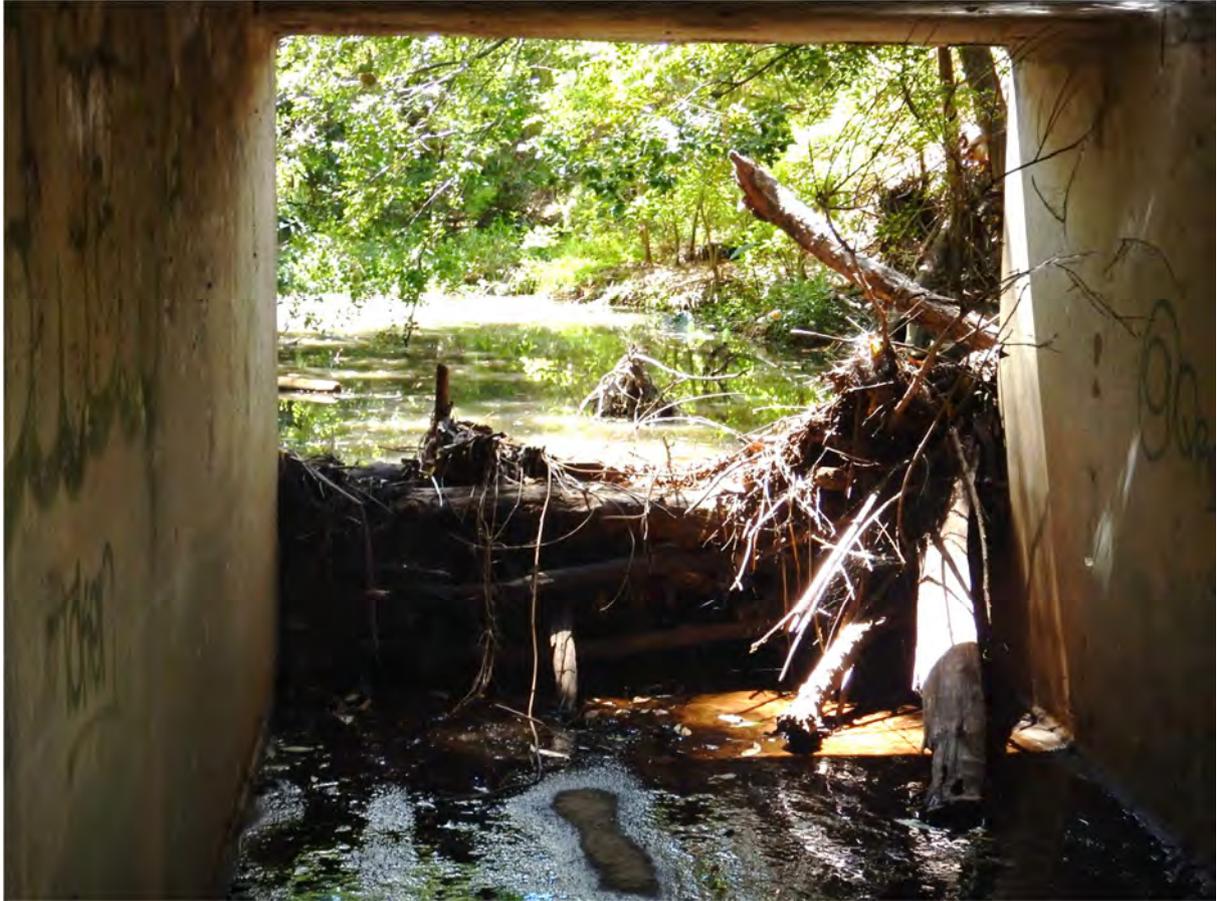
The culverts that form a part of the structure of an abandoned rail bridge located along a section of the eastern border of the subject site through which Vineyard Creek flows appear to be partially blocked by various large pieces of debris (**Plate 7**). These large pieces of debris were lodged perpendicular to the flow of the creek and appeared to be damming Vineyard Creek.

Plate 7. Debris blocking the rail bridge culvert within Vineyard Creek on the eastern extent of the subject site

Narla Environmental recommends that all pieces of debris found to be affecting or restricting the flow of Vineyard Creek are removed in order to restore the natural water flow to the creek line as well as annul the significant risk of flooding posed by the debris during heavy rainfall events. The management of this issue, present on the western side of the disused railway bridge may be the responsibility of either the City of Parramatta Council or the adjoining land holders located on the eastern side of the subject site.
