# Vineyard Creek Bushland Management Plan

# Bushland Management Strategy

Vineyard Creek, Western Sydney University Parramatta  
Campus

Report prepared by Narla Environmental Pty Ltd

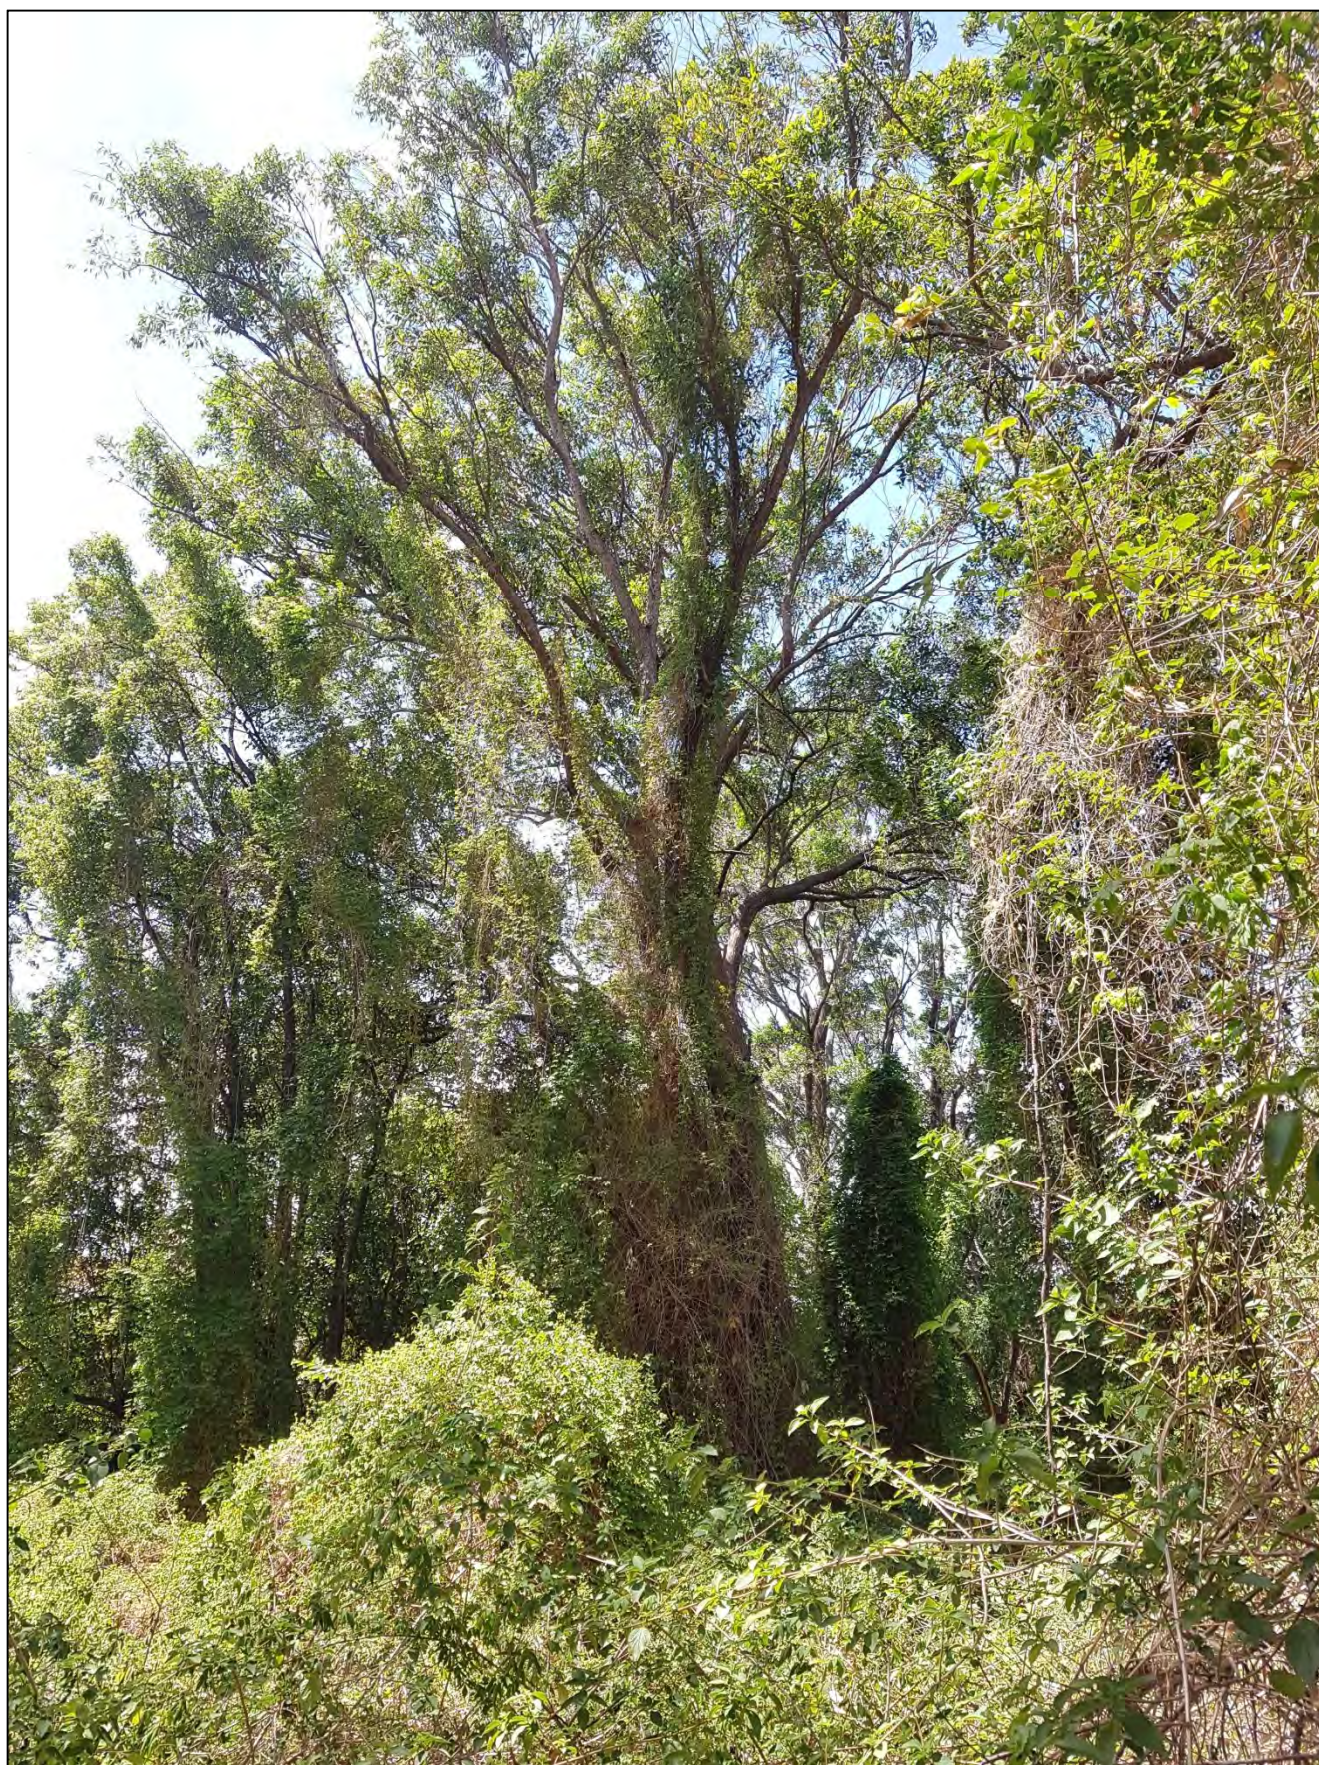
**Plate 2. Invasive vines and climbers threatening the viability of the native canopy in the subject site**

Weed infestation is considered to be the most significant management issue affecting the subject site. Nara recommend that the professional management of weeds is implemented as soon as is practicable and that priority be given to remove and control WoNS and weed species listed as 'priority' within the Greater Sydney area. Effort should be made to progressively expand the quality of native vegetation communities through the gradual replacement of weeds with ecologically-equivalent native plants. This can be achieved through the action of professional Bushland Restoration professionals with the aid of on-going efforts driven by volunteers (e.g. local environment groups, university bushland / environmental clubs or BushCare Groups).

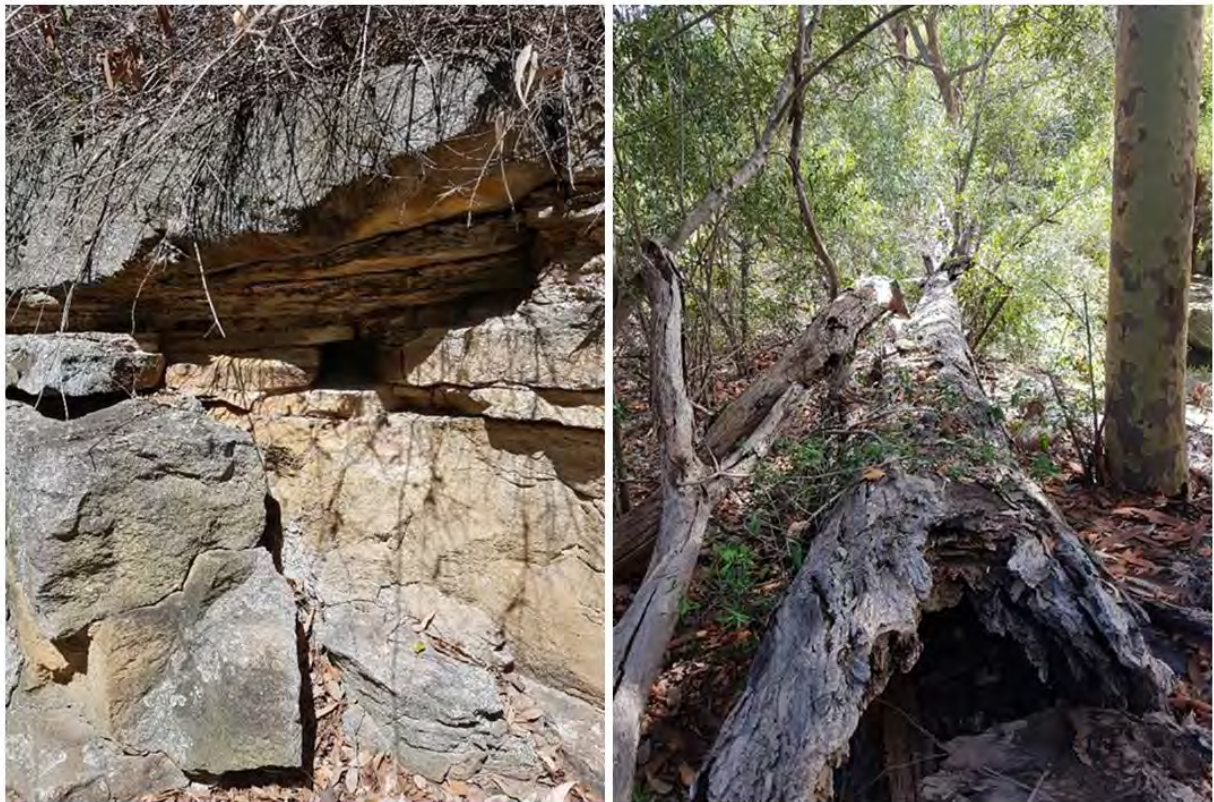
**Plate 3. Important fauna habitat features on the subject site (sandstone crevices left) and coarse woody debris (right)**

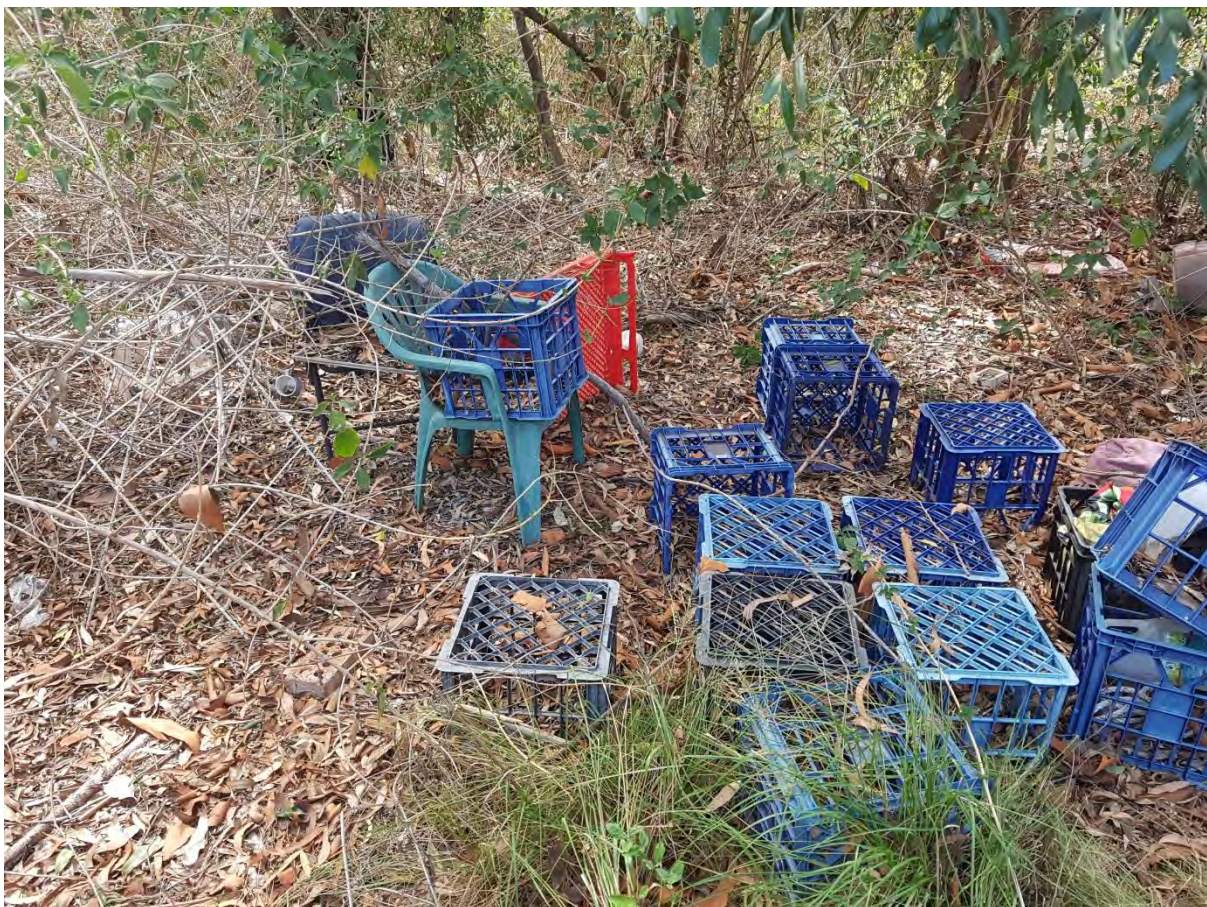
The illegal dumping of waste material and illegitimate occupancy of the site was identified as a management issue. A dumped car engine block as well as an abandoned camp (**Plate 4**) were identified within the subject site. Disturbed areas where dumping occurs are likely to support weed plumes and infestations. Such areas may also be susceptible to increased risk of fire or erosion. Waste products could enter the riparian environment and cause environmental degradation.

**Plate 4. Evidence of illegal camp within the subject site.**

It is recommended that the University installs permanent fencing located along the edge of vegetated areas to prevent unauthorised access and maximise protection of the EEC and habitat values. A suitable place for fence installation would be between the cycle way and native vegetation. The installation of a chain-link fence with a gate, or even a simple post and wire style fence would provide the added benefit of a deterrent to would be vandals or trespassers.

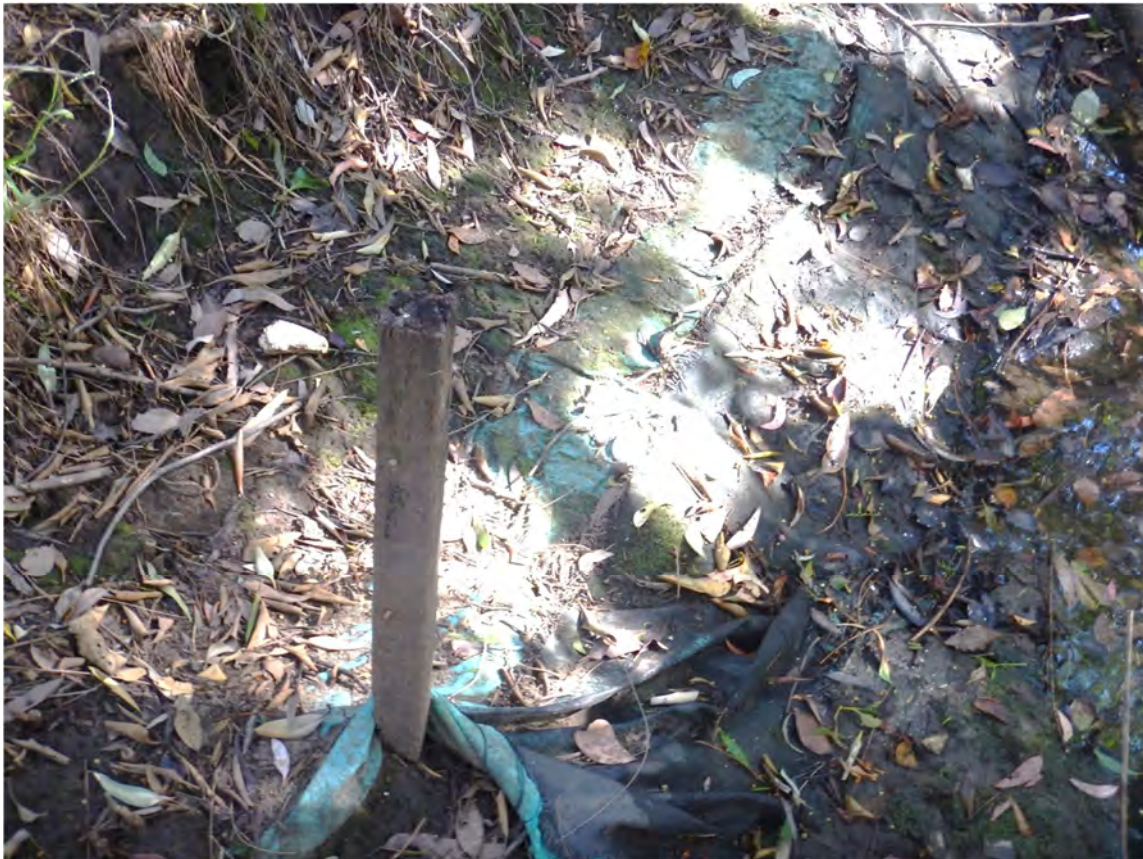
Small areas of localised erosion were evident within the subject site. Past erosion control measures were evident along areas within the southern extent of Vineyard Creek in the form of erosion fencing. This fencing was intact in areas and had been compromised in other areas (**Plate 5**). Increased sedimentation of vineyard Creek is likely to reduce the habitability of the watercourse for native aquatic and semi-aquatic fauna.

**Plate 5. Compromised sediment retention fencing along Vineyard Creek**

It is recommended that the damaged sediment fencing along the western bank of Vineyard Creek, in the southern extent of the subject site be at least removed and ideally, replaced. As the damaged fencing material continues to deteriorate, it poses a risk to the health of the native fauna within the creek as well as not preventing the mobilisation of sediments and other material into the water course as it is intended to do.

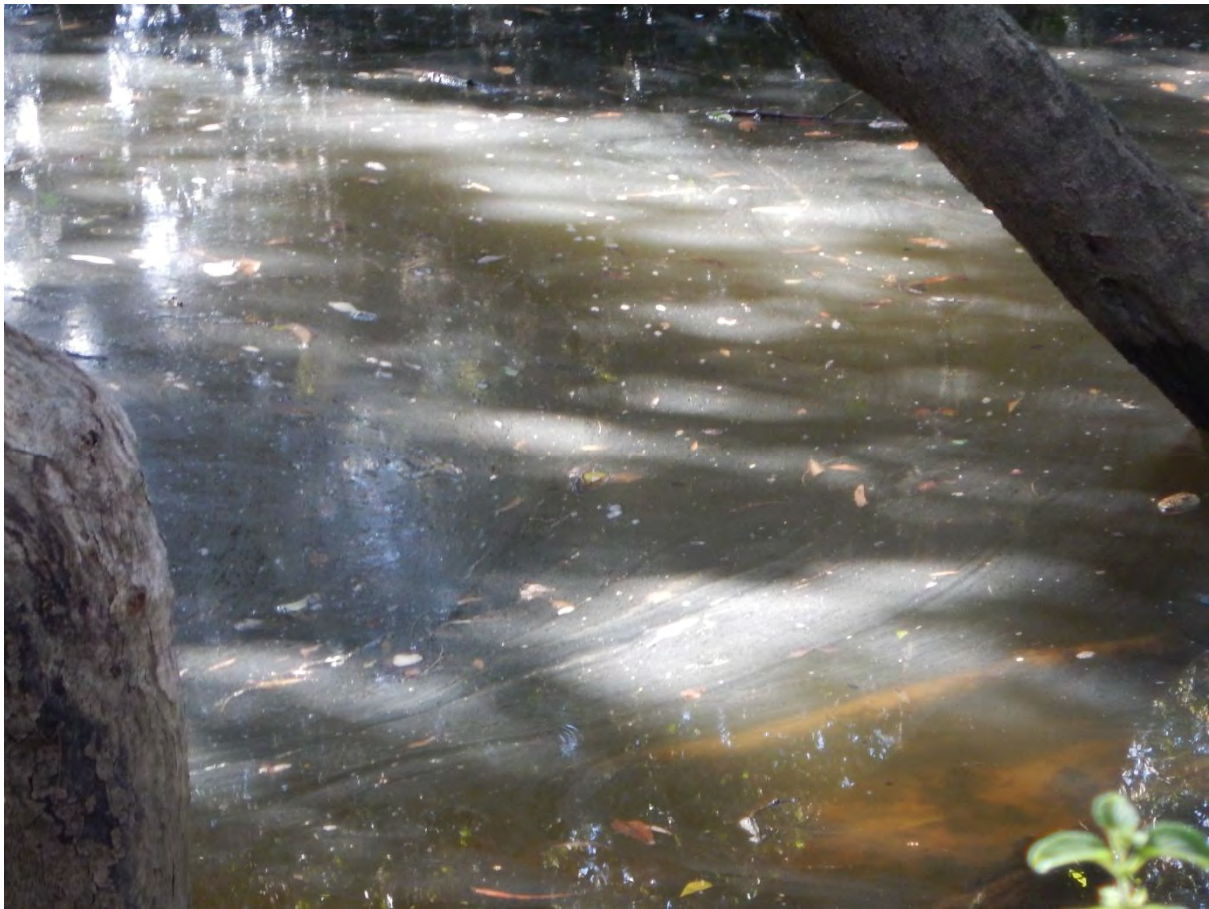
The water within Vineyard Creek was observed to contain both micro and macro pollutants, including a dense surface slick (**Plate 6**). A considerable amount of plastic waste had entered the subject site, presumably via the northern extent of vineyard creek.

**Plate 6. Pollution within Vineyard Creek**

As a result of the visible macro and micro pollution observed within Vineyard Creek, Narla Environmental recommends the implementation of a floating pollution collection/ exclusion boom to reduce the impact of water borne pollution within the subject site. Such a device should be implemented at the northern extent of the subject site where it could prevent the mobilisation of macro-pollutants throughout the subject site and would not inhibit the dispersal of mangrove propagules within the brackish, southern extent of the subject site.

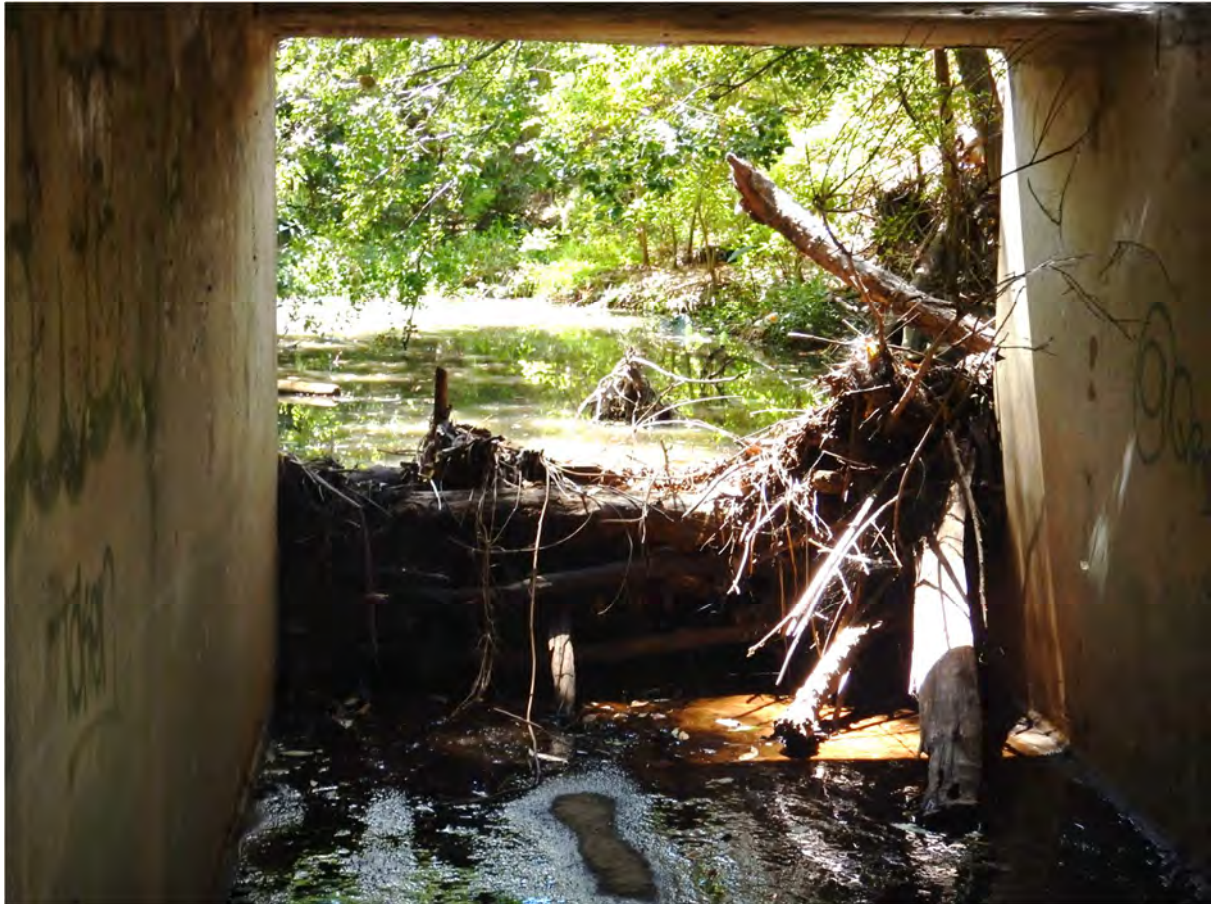
The culverts that form a part of the structure of an abandoned rail bridge located along a section of the eastern border of the subject site through which Vineyard Creek flows appear to be partially blocked by various large pieces of debris (**Plate 7**). These large pieces of debris were lodged perpendicular to the flow of the creek and appeared to be damming Vineyard Creek.

**Plate 7. Debris blocking the rail bridge culvert within Vineyard Creek on the eastern extent of the subject site**

Narla Environmental recommends that all pieces of debris found to be affecting or restricting the flow of Vineyard Creek are removed in order to restore the natural water flow to the creek line as well as annul the significant risk of flooding posed by the debris during heavy rainfall events. The management of this issue, present on the western side of the disused railway bridge may be the responsibility of either the City of Parramatta Council or the adjoining land holders located on the eastern side of the subject site.
